# HOME REPORT

# Energy Performance Certificate (EPC)

THE FIRS, 70 BELTIE ROAD, TORPHINS, BANCHORY, AB31 4JT

# Single Survey

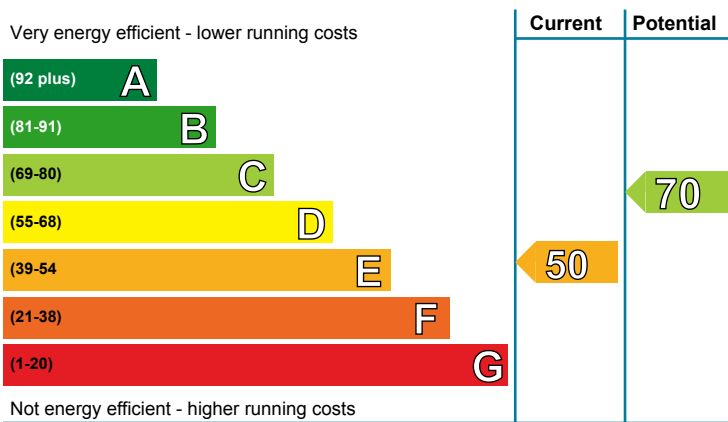
## Energy Efficiency Rating

This graph shows the current efficiency of your home, taking into account both energy efficiency and fuel costs. The higher this rating, the lower your fuel bills are likely to be.

Your current rating is **band E (50)**. The average rating for EPCs in Scotland is **band D (61)**.

The potential rating shows the effect of undertaking all of the improvement measures listed within your recommendations report.
