# Home Report

# Scottish Single Survey

<b>Property address</b>	2 Auchlinn Cottages Fisherie Turriff AB53 5RT
<b>Customer</b>	Mr and Mrs J Clubb
<b>Customer address</b>	2 Auchlinn Cottages Fisherie Turriff AB53 5RT
<b>Prepared by</b>	Shepherd Chartered Surveyors
<b>Date of inspection</b>	18/03/2024

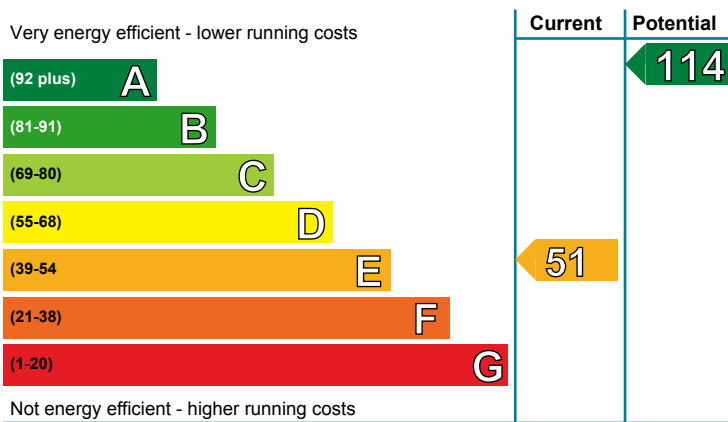
## Energy Efficiency Rating

This graph shows the current efficiency of your home, taking into account both energy efficiency and fuel costs. The higher this rating, the lower your fuel bills are likely to be.

Your current rating is **band E (51)**. The average rating for EPCs in Scotland is **band D (61)**.

The potential rating shows the effect of undertaking all of the improvement measures listed within your recommendations report.

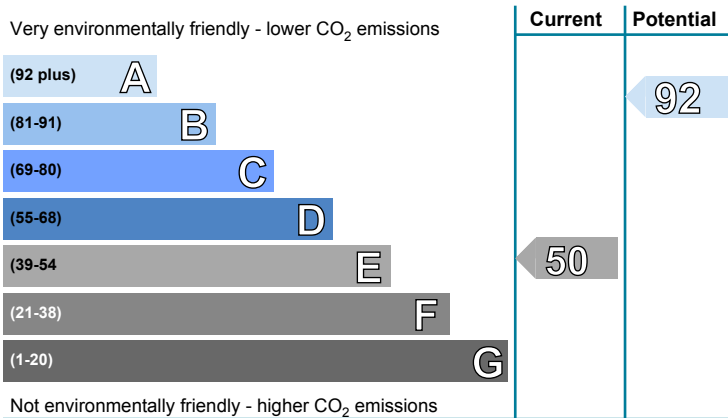
## Environmental Impact (CO<sub>2</sub>) Rating

This graph shows the effect of your home on the environment in terms of carbon dioxide (CO<sub>2</sub>) emissions. The higher the rating, the less impact it has on the environment.
