YOUR ONESURVEY
HOME REPORT

39 Belhaven Terrace
Wishaw
ML2 7AY

SINGLE SURVEY

Single Survey

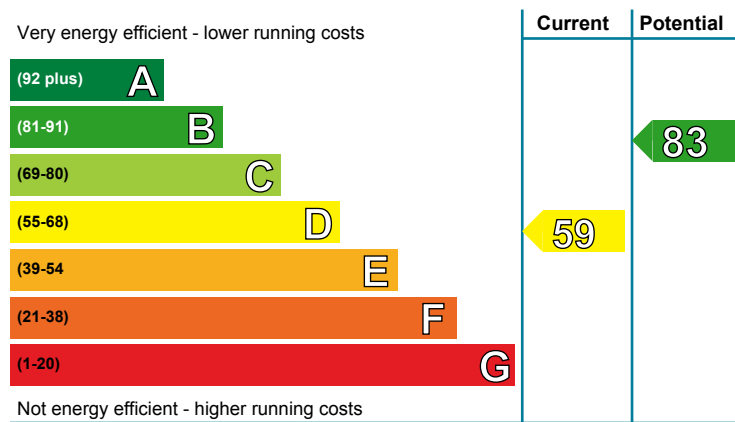
Energy Efficiency Rating

This graph shows the current efficiency of your home, taking into account both energy efficiency and fuel costs. The higher this rating, the lower your fuel bills are likely to be.

Your current rating is **band D (59)**. The average rating for EPCs in Scotland is **band D (61)**.

The potential rating shows the effect of undertaking all of the improvement measures listed within your recommendations report.

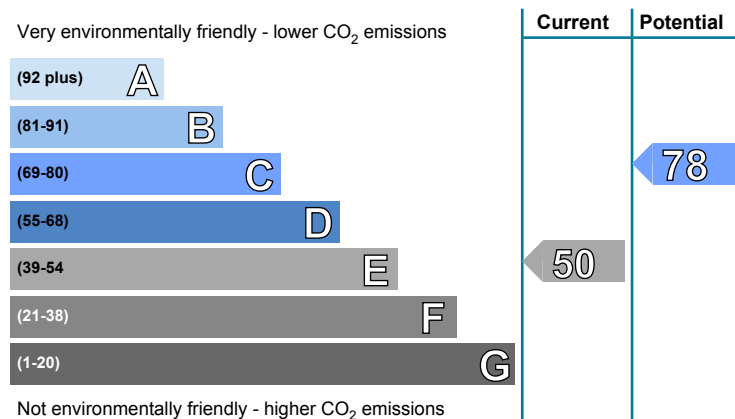
Environmental Impact (CO₂) Rating

This graph shows the effect of your home on the environment in terms of carbon dioxide (CO₂) emissions. The higher the rating, the less impact it has on the environment.
