Home Report

Scottish Single Survey

Property address	48 Tullos Crescent Aberdeen AB11 8JW
-------------------------	--

Prepared by	Shepherd Chartered Surveyors
--------------------	------------------------------

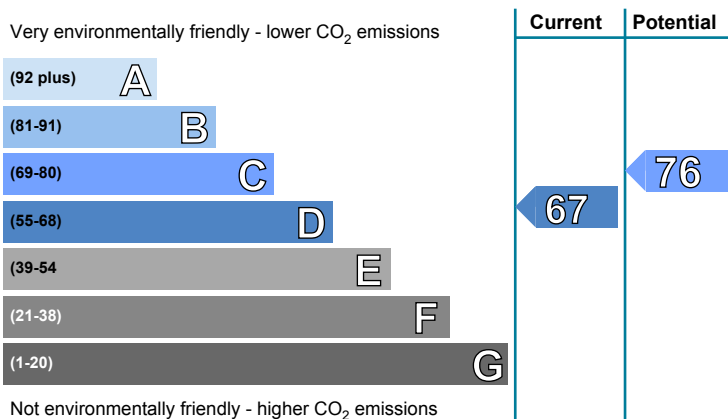
Environmental Impact (CO₂) Rating

This graph shows the effect of your home on the environment in terms of carbon dioxide (CO₂) emissions. The higher the rating, the less impact it has on the environment.
