YOUR ONESURVEY  
**HOME REPORT**

108 Crawford Street  
Motherwell  
ML1 3BN

# SINGLE SURVEY

# Single Survey

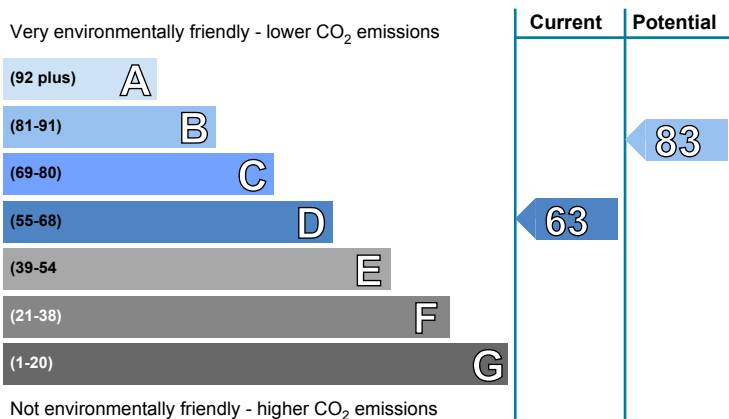
## Environmental Impact (CO<sub>2</sub>) Rating

This graph shows the effect of your home on the environment in terms of carbon dioxide (CO<sub>2</sub>) emissions. The higher the rating, the less impact it has on the environment.
